RAF Upper Rissington
S278 Works
Road Safety Audit Stage 1
Gladedale

November 2010

RAF Upper Rissington
S278 Works
Designers Response to RSA1
Gladedale Homes

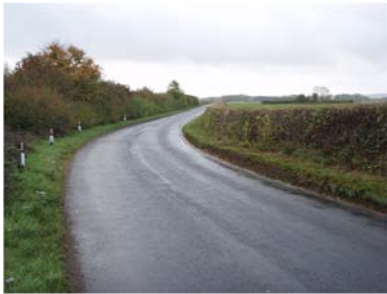
LOCATION: South of the new priority junction

SUMMARY: Inadequate road width could lead to side-swipe incidents.

The proposed carriageway half-width at some locations is 2.5m. This is considered inadequate for the main road with significant HGVs. This could lead to passing HGVs coming into conflict, as they pass each other.

Designers Response: The carriageway widths provided throughout the junctions are a minimum of 3.0m as TD 452/95 and TD 16/07. Beyond the extents of the works the existing carriageway widths will be maintained due to minimal land availability and the need to retain a residential character to the roads through the village.

Ensure that a minimum width of 3m is used for each lane throughout the scheme.

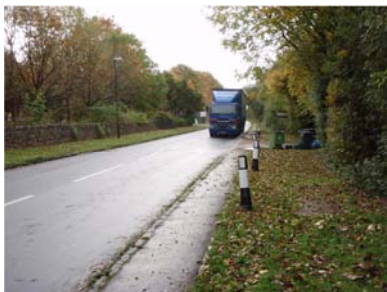
LOCATION: The re-aligned side road junction

SUMMARY: Close proximity of the side road junction to the roundabout may lead to shunt type incidents

The close proximity of the re-aligned side road junction to the roundabout could cause drivers confusion. The southbound vehicles egressing the roundabout may fail to realise in sufficient time that a vehicle in front is turning right into the side road. This could result in shunt type accidents.

Designers Response: Visibility provision throughout the junction is to standards contained within DMRB. There is also no guidance on the proximity of junctions to a roundabout however if the approach to the junction location is assessed in the same way as a pedestrian crossing then a location within 20m of the roundabout or more than 60m should be used. In this instance we feel that due to the limited number of vehicles using the junction and also the low speeds of mainline traffic at the roundabout that the location proposed

Ensure that there is adequate forward visibility at the approach to the side road junction. The distance between the roundabout and adjacent junction should be increased.
